Situation Photo Log

Wednesday, June 20, 2012

Kalamazoo River / Enbridge Spill

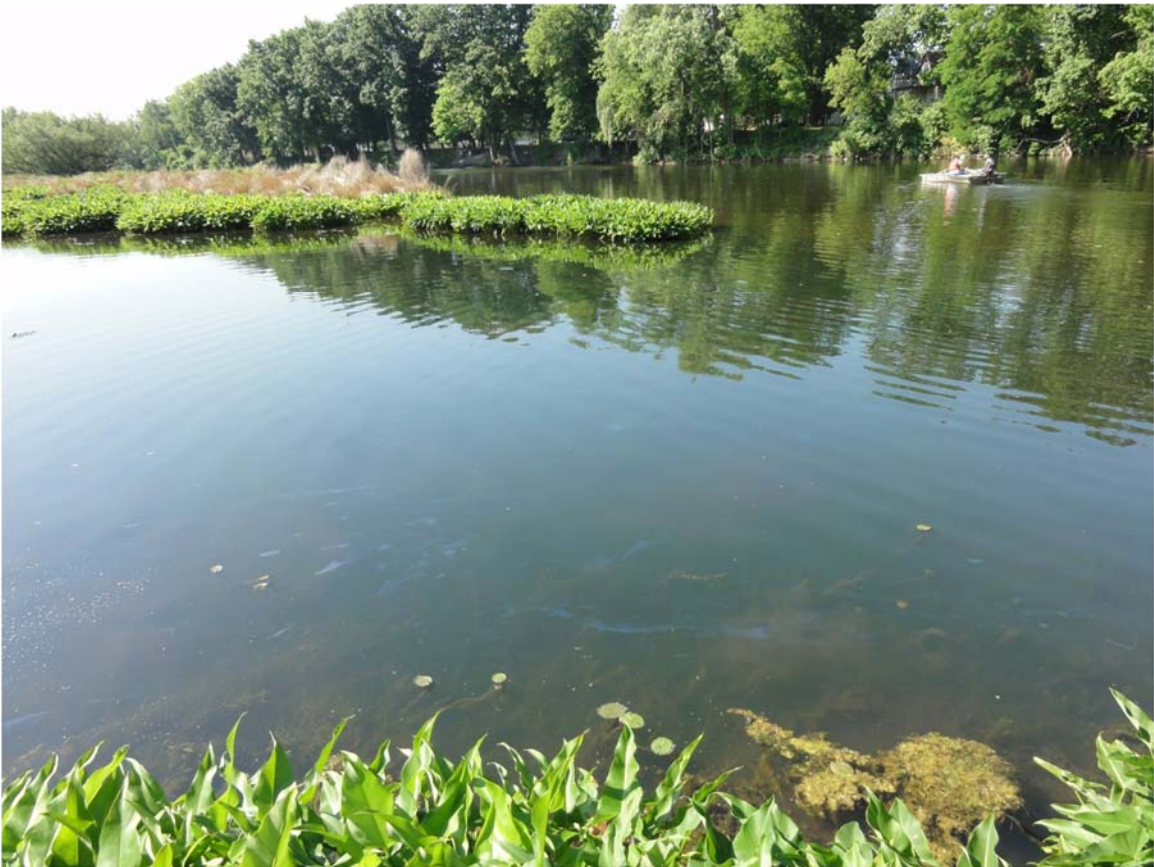
24. MP15.5 Mill Pond sheen observed.

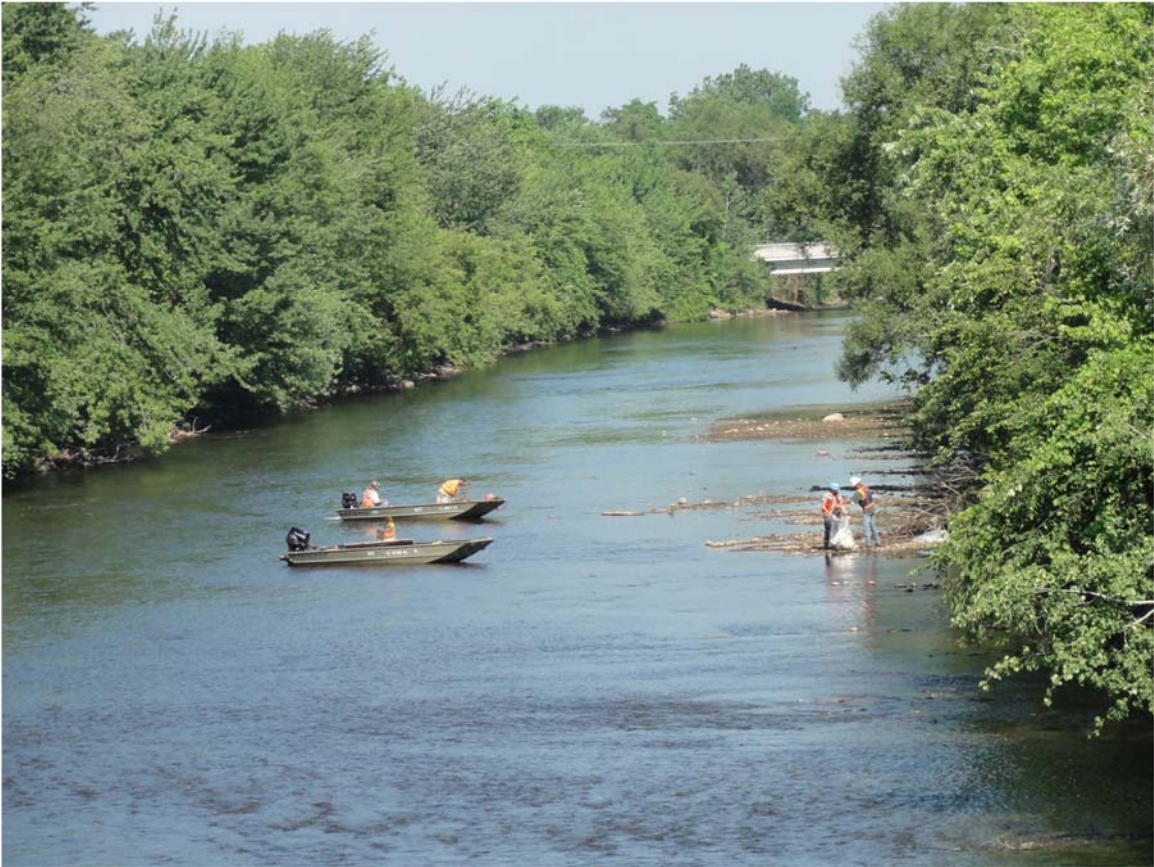
25. MP17.0 Observed crew removing debris from river.

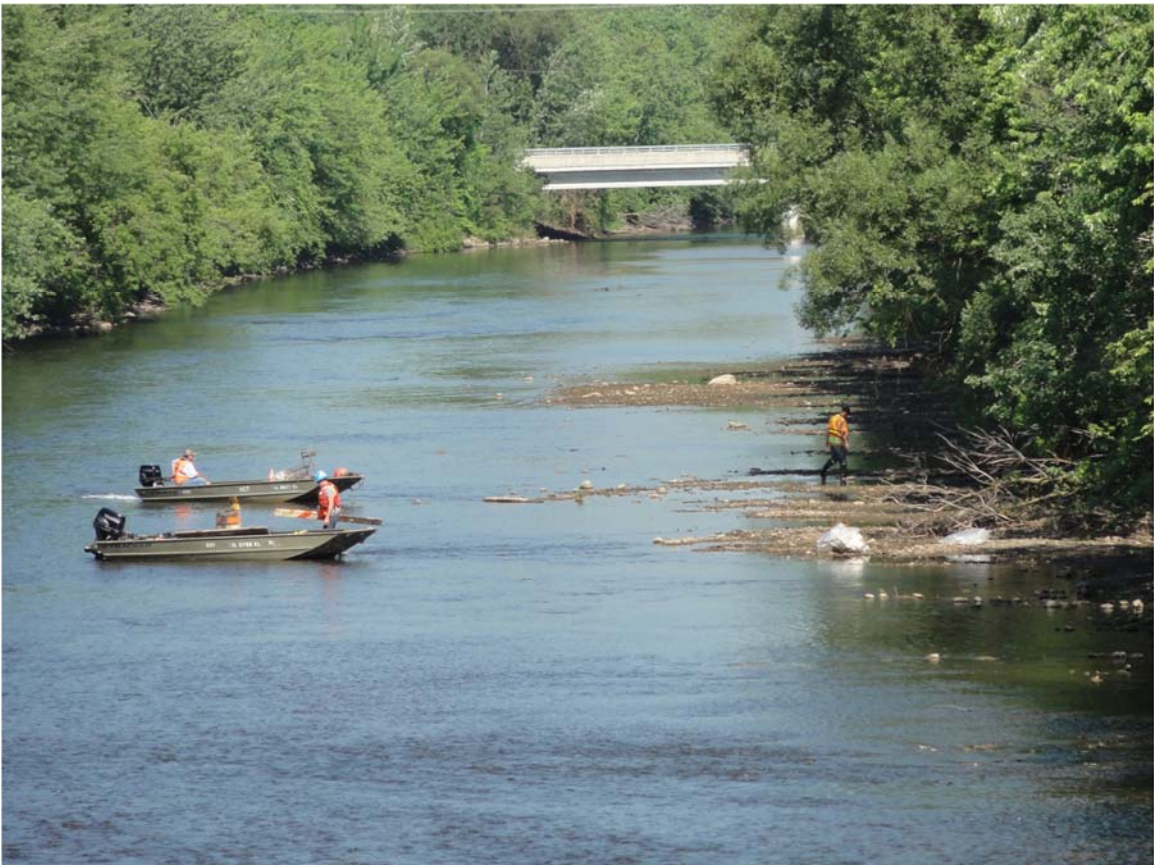
26. MP17.0 Observed crew removing debris from river.

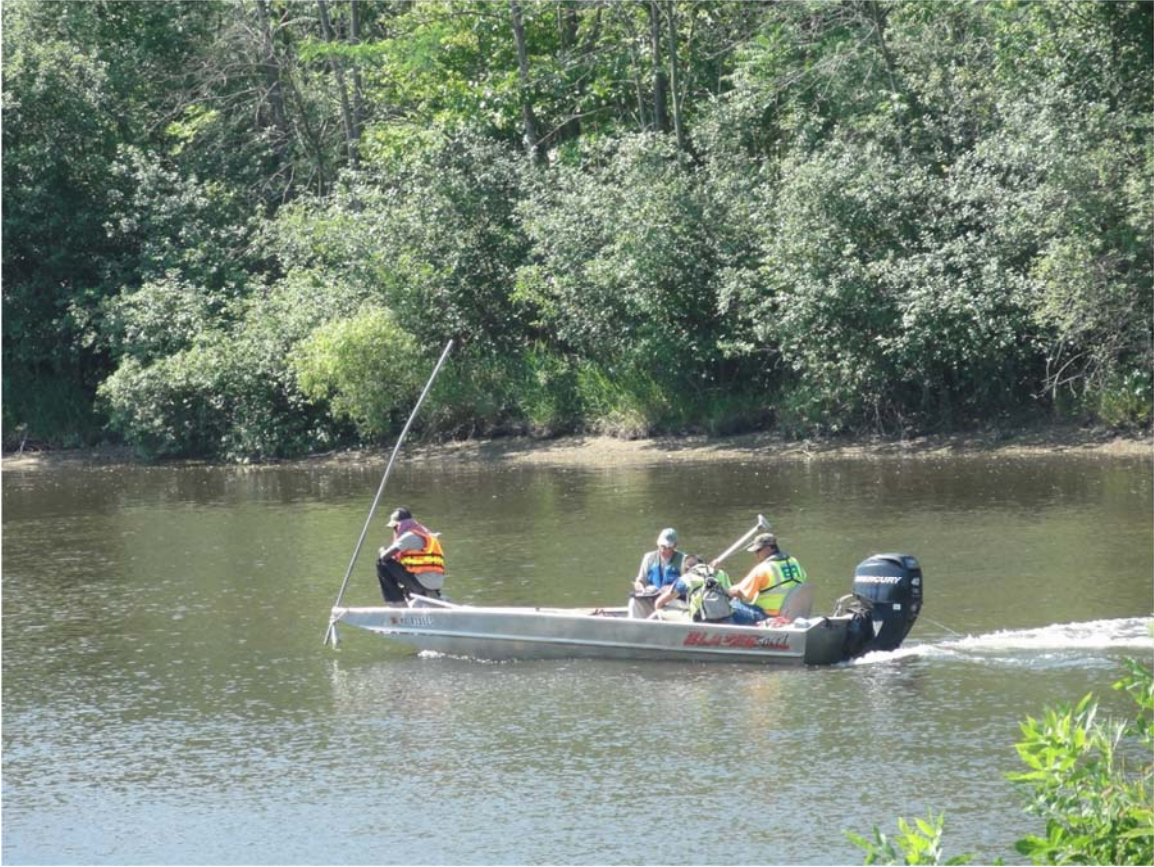
27. MP17.5 Observed poling crew.

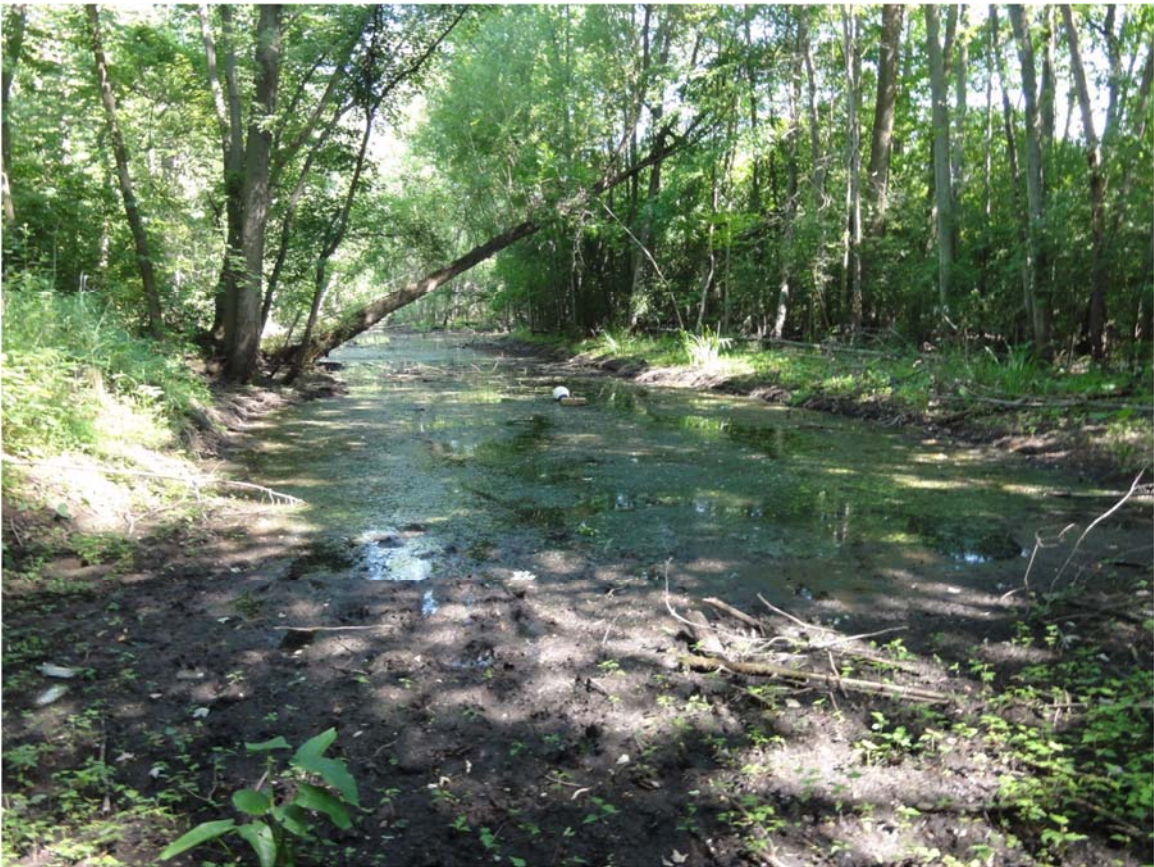
28. MP19.25 Back channel.

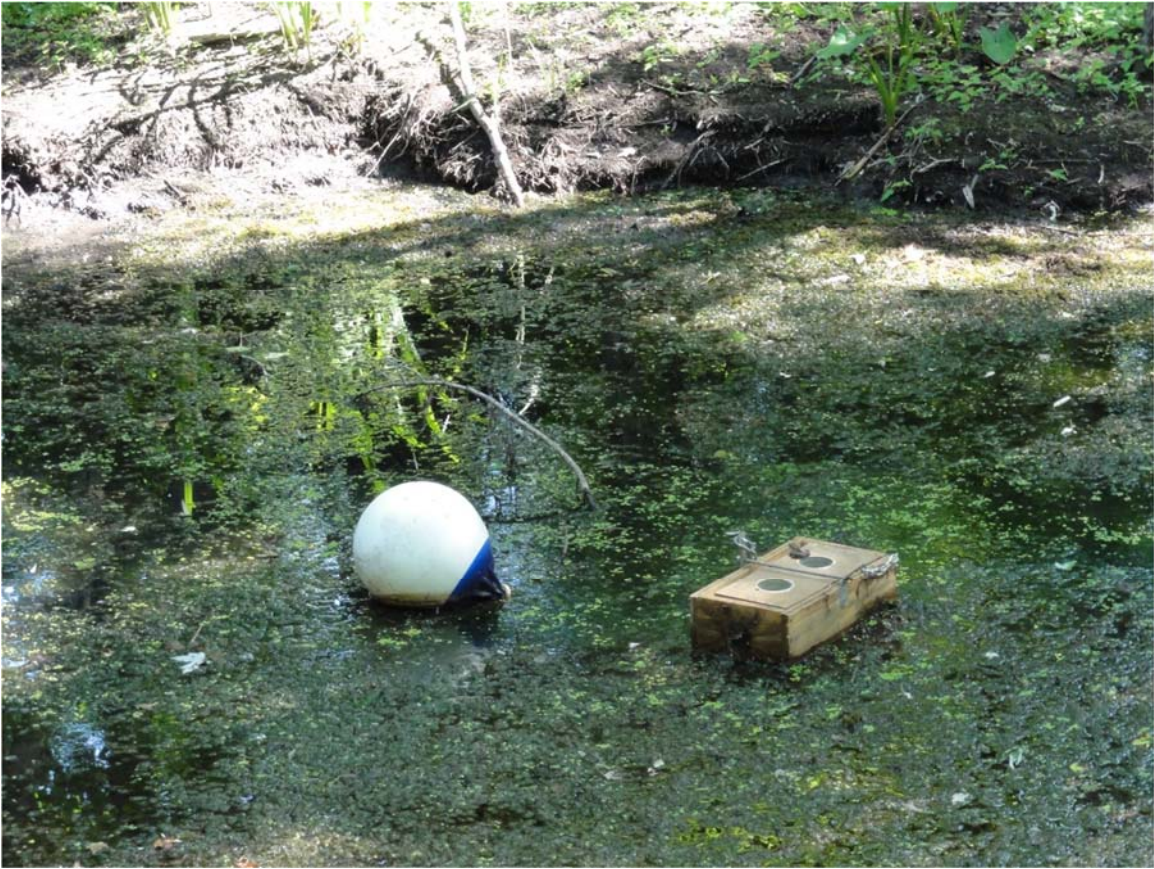
29. MP19.25 Back channel sampling device.

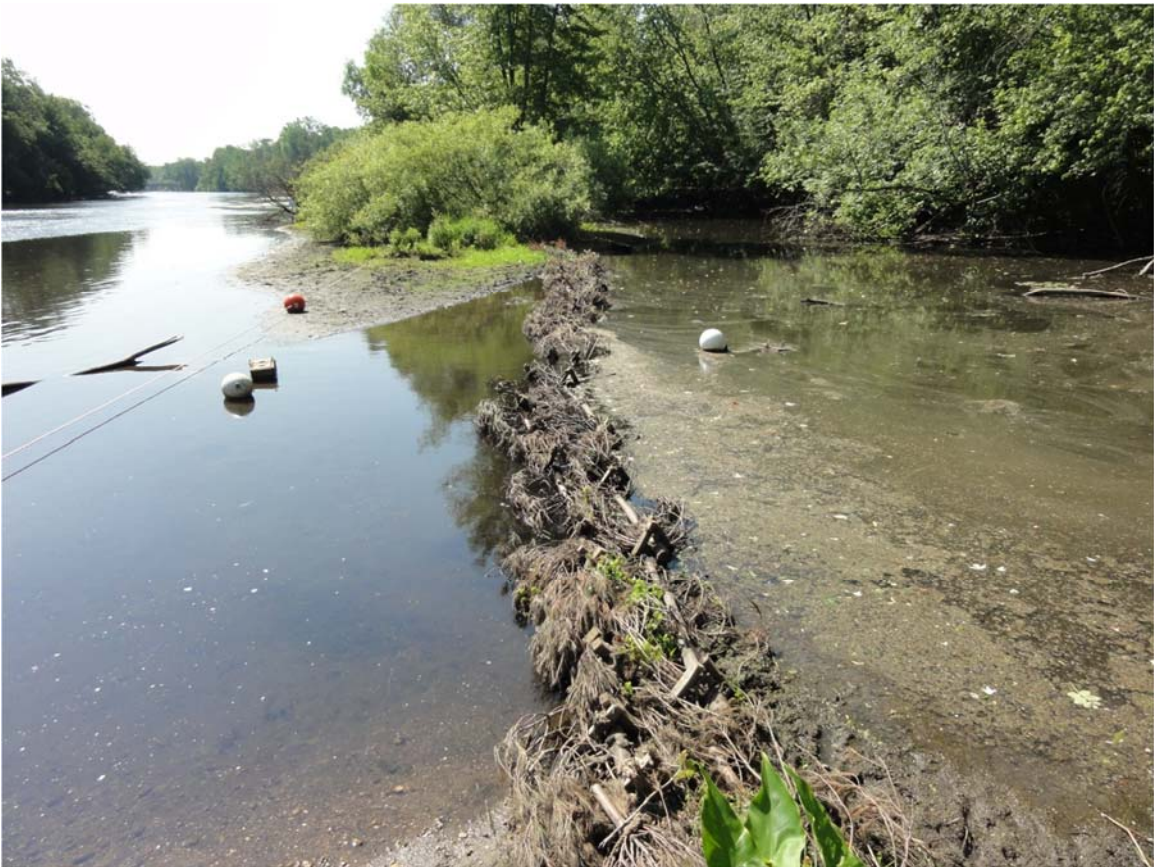
30. MP19.25 Sediment trap.

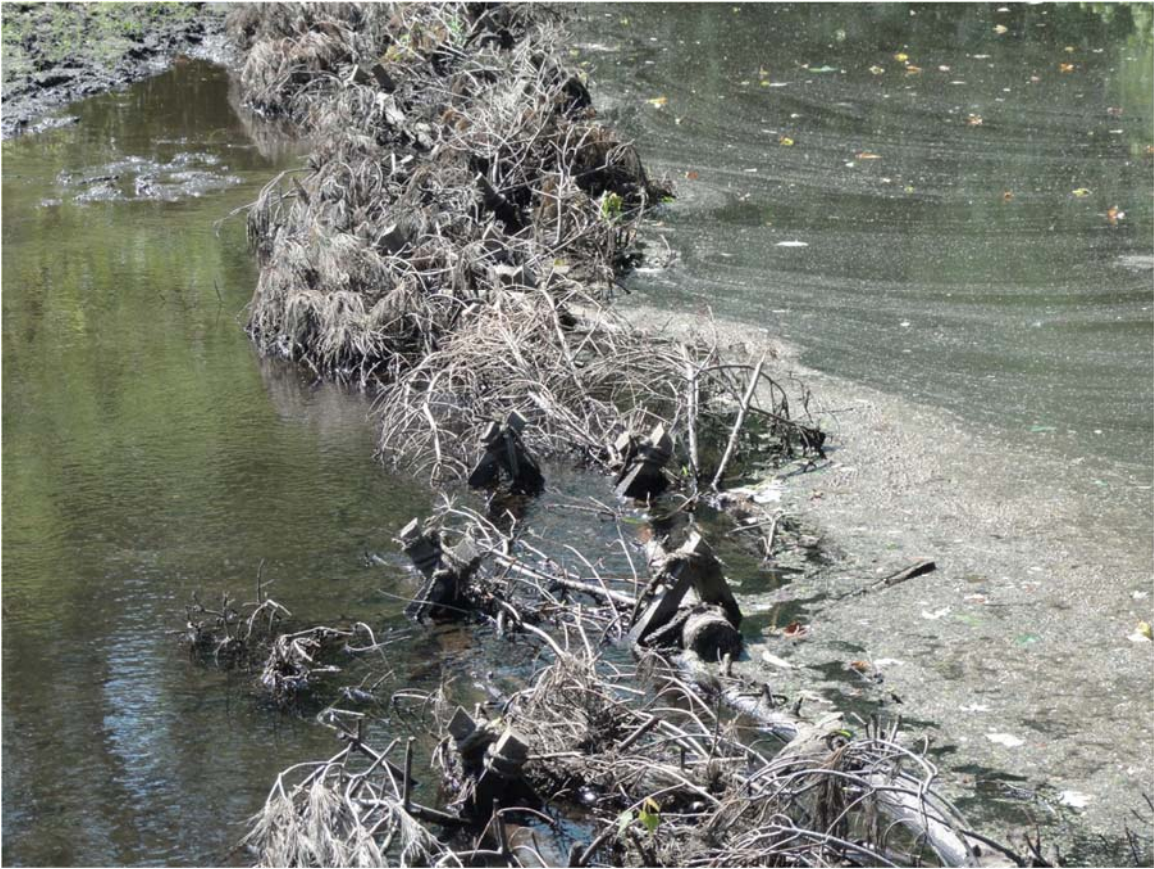
31. MP19.25 Sediment trap.

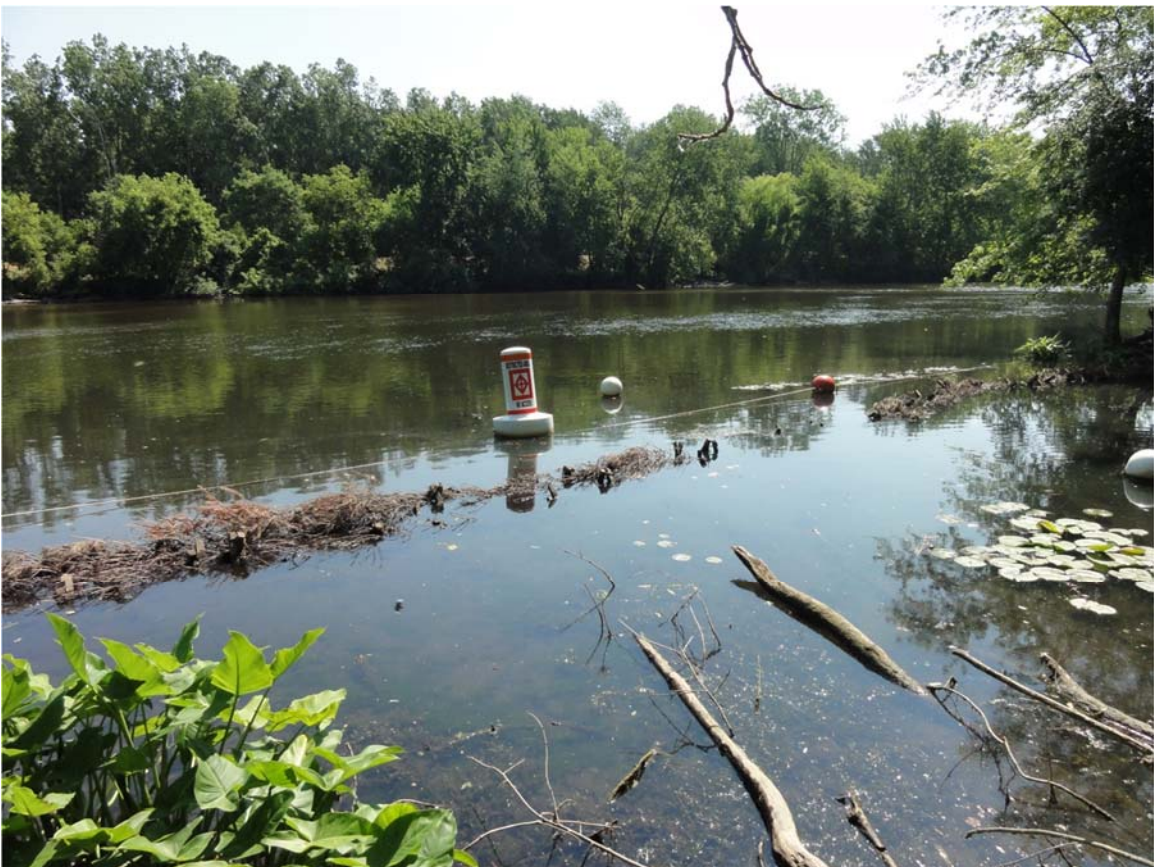
32. MP19.25 Sediment trap.

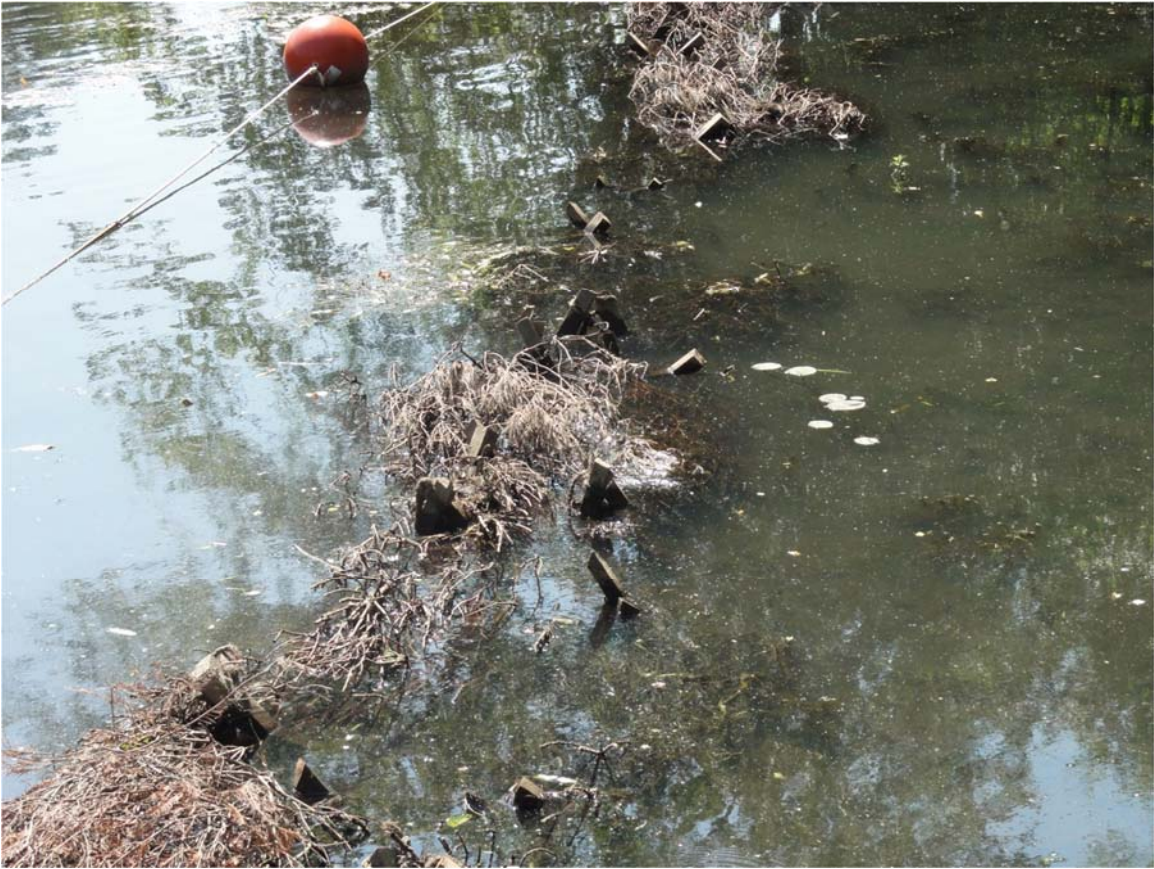
33. MP19.25 Sediment trap.

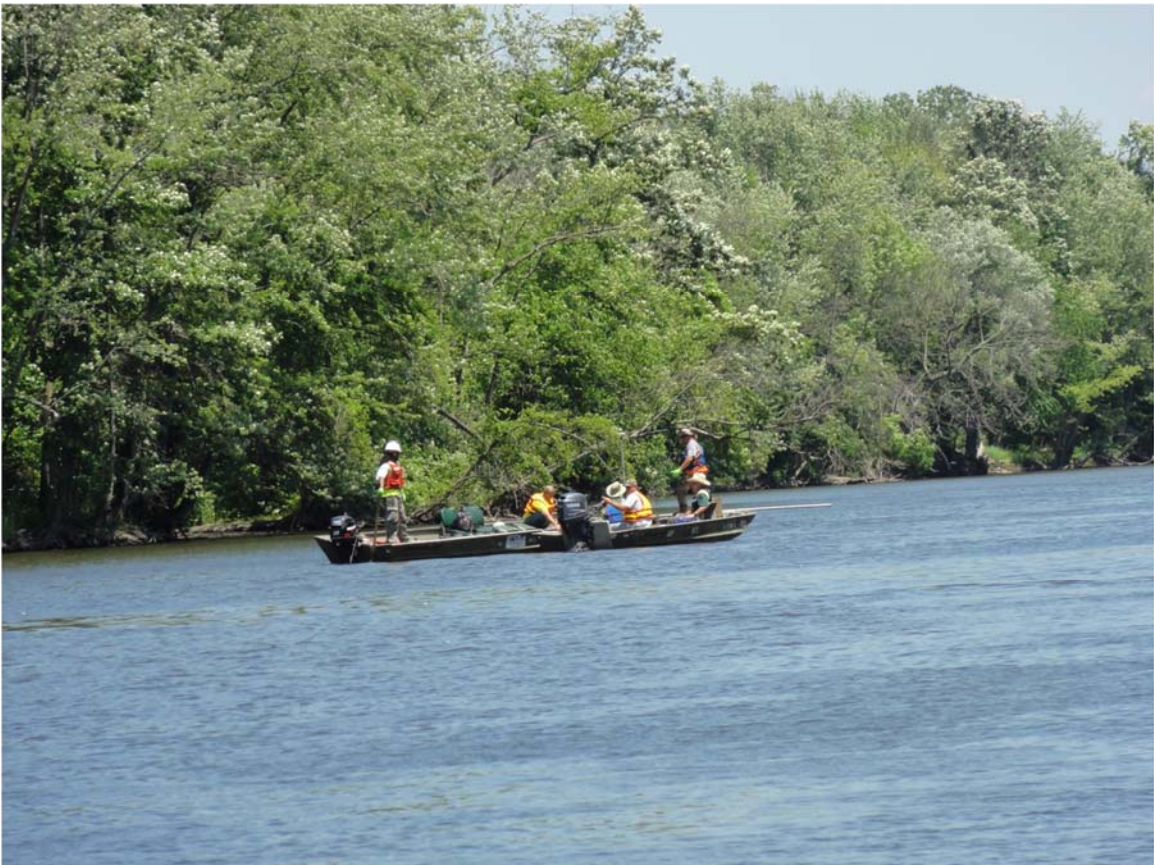
34. MP34.5 poling crew observed.

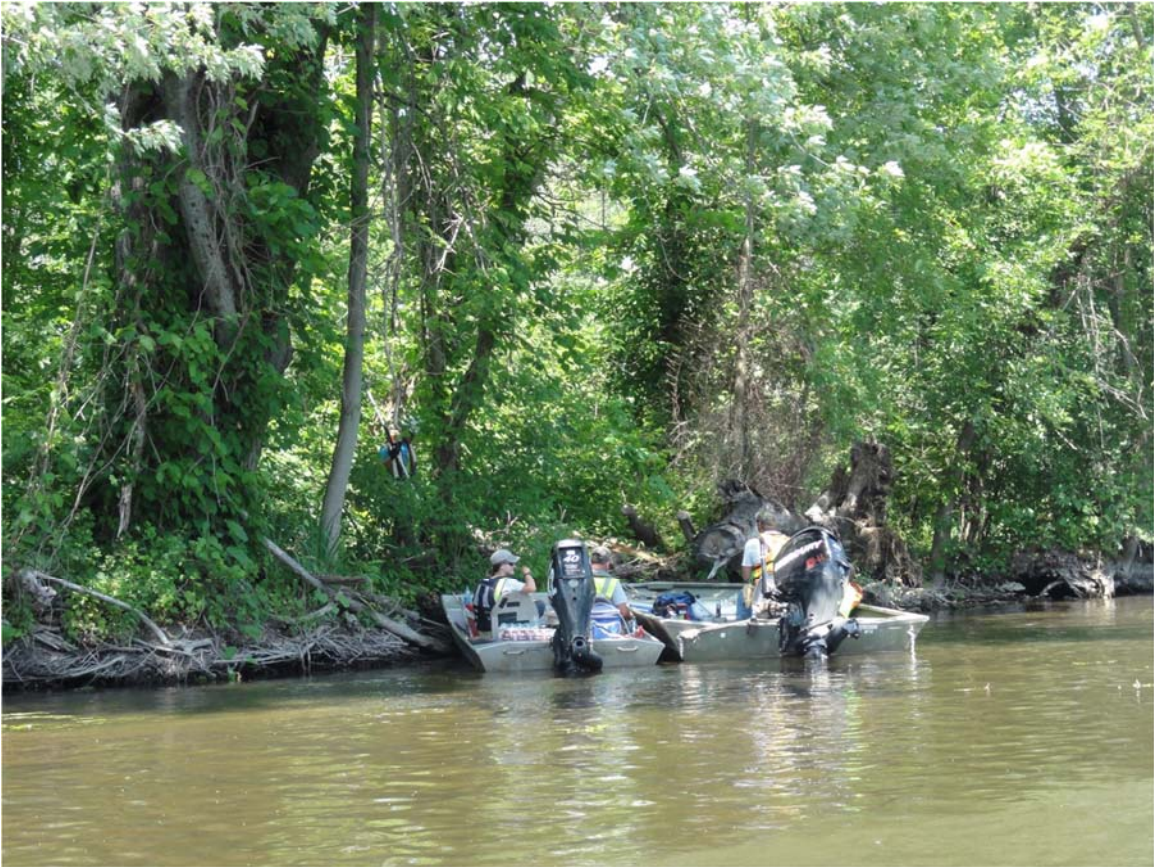
35. MP36.0 observed reassessment team.

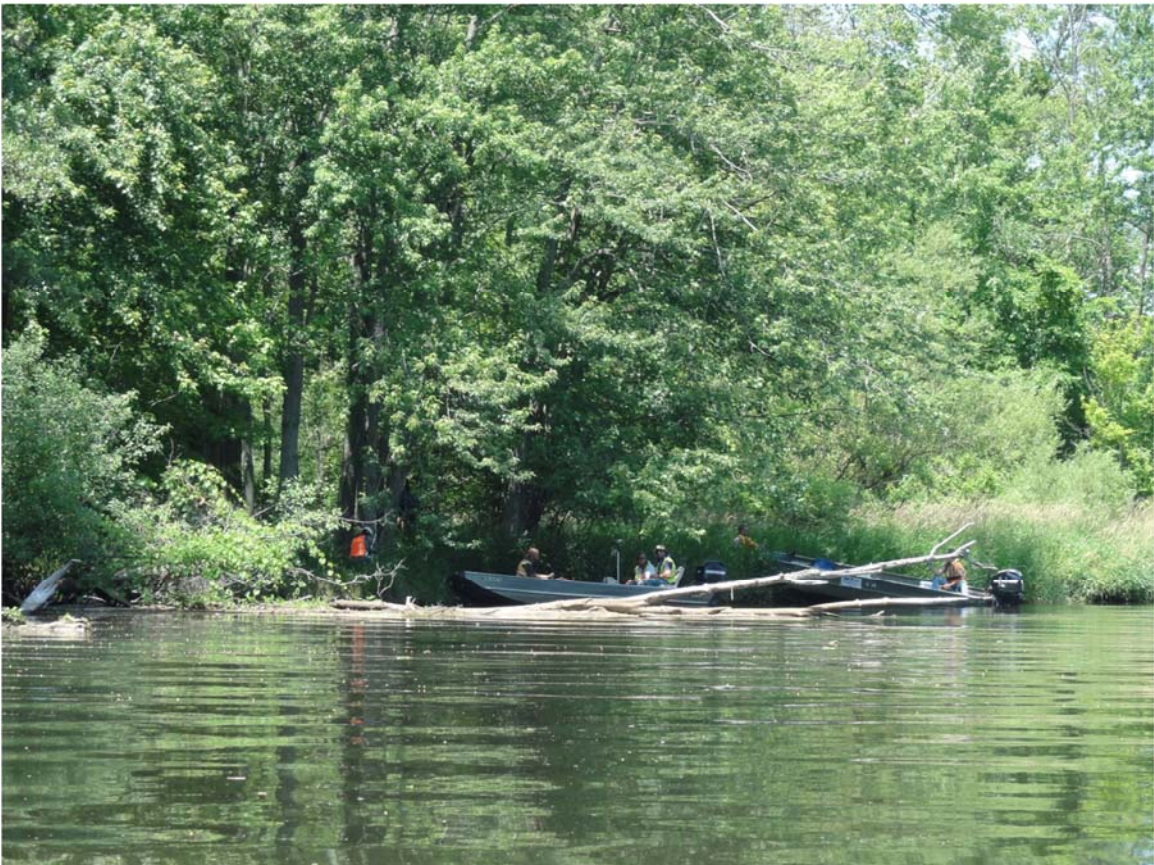
36. MP36.5 Observed reassessment team.

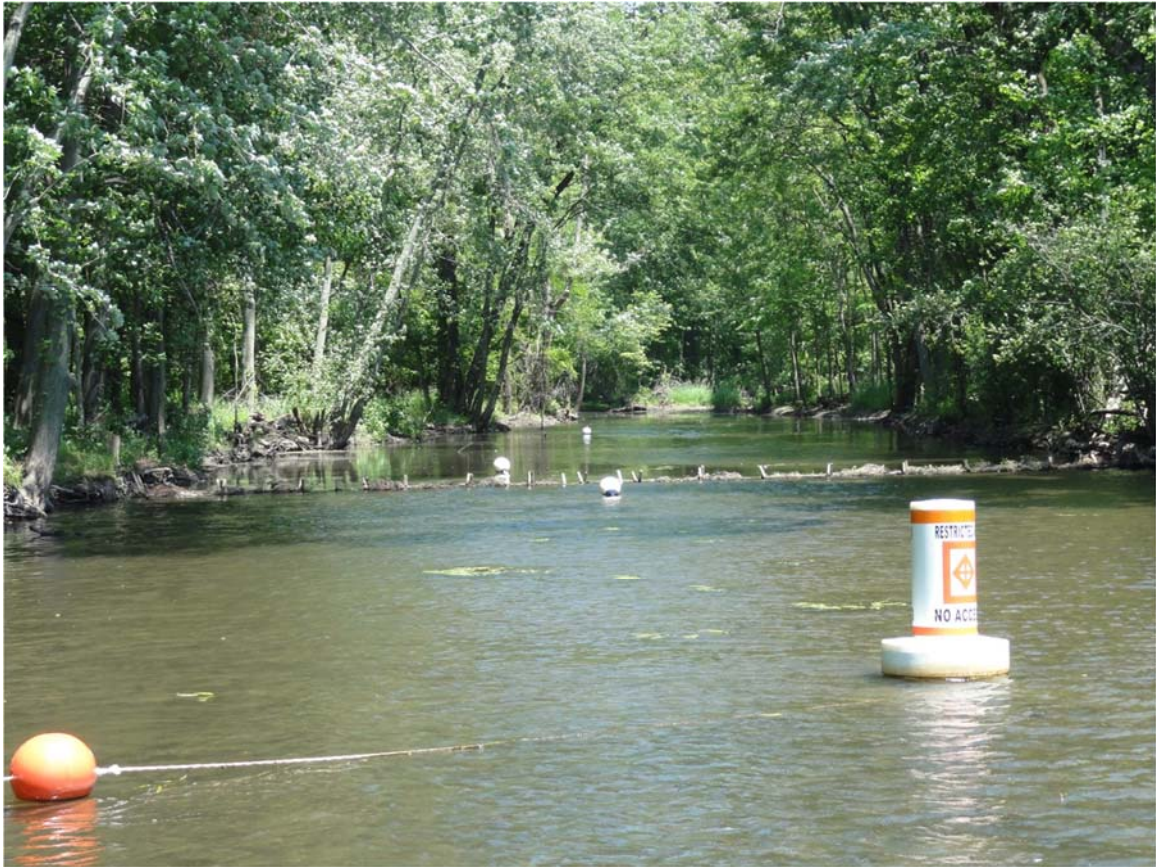
37. MP36.1 Sediment trap.

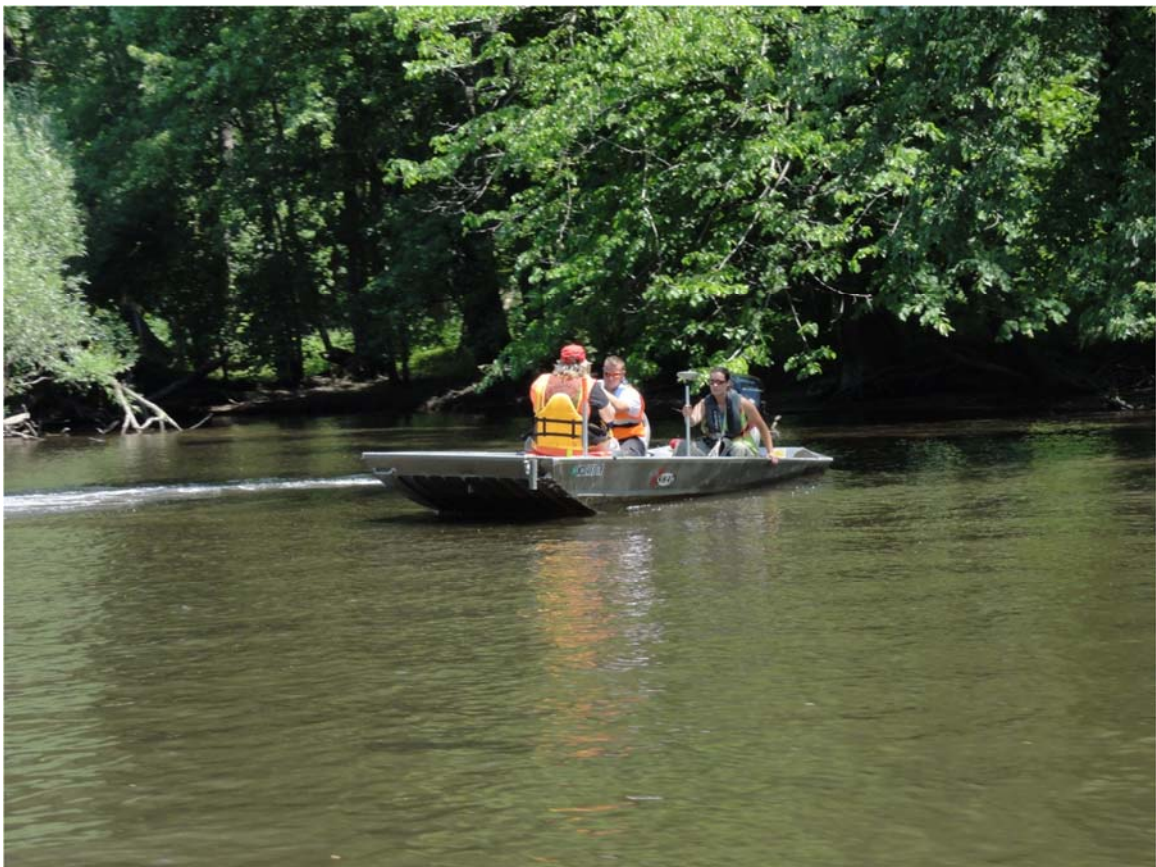
38. MP31.75 Observed reassessment team.

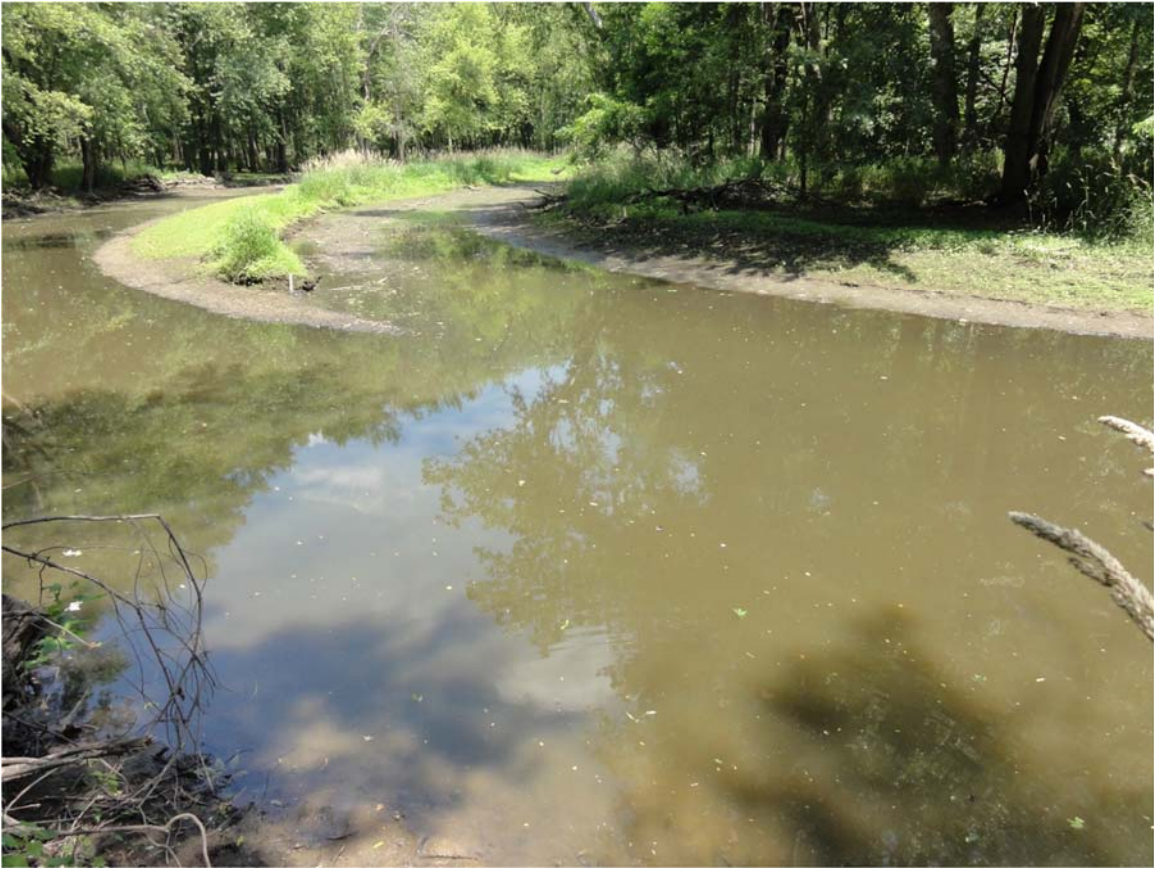
39. MP28.25 Oxbow sheen observed.

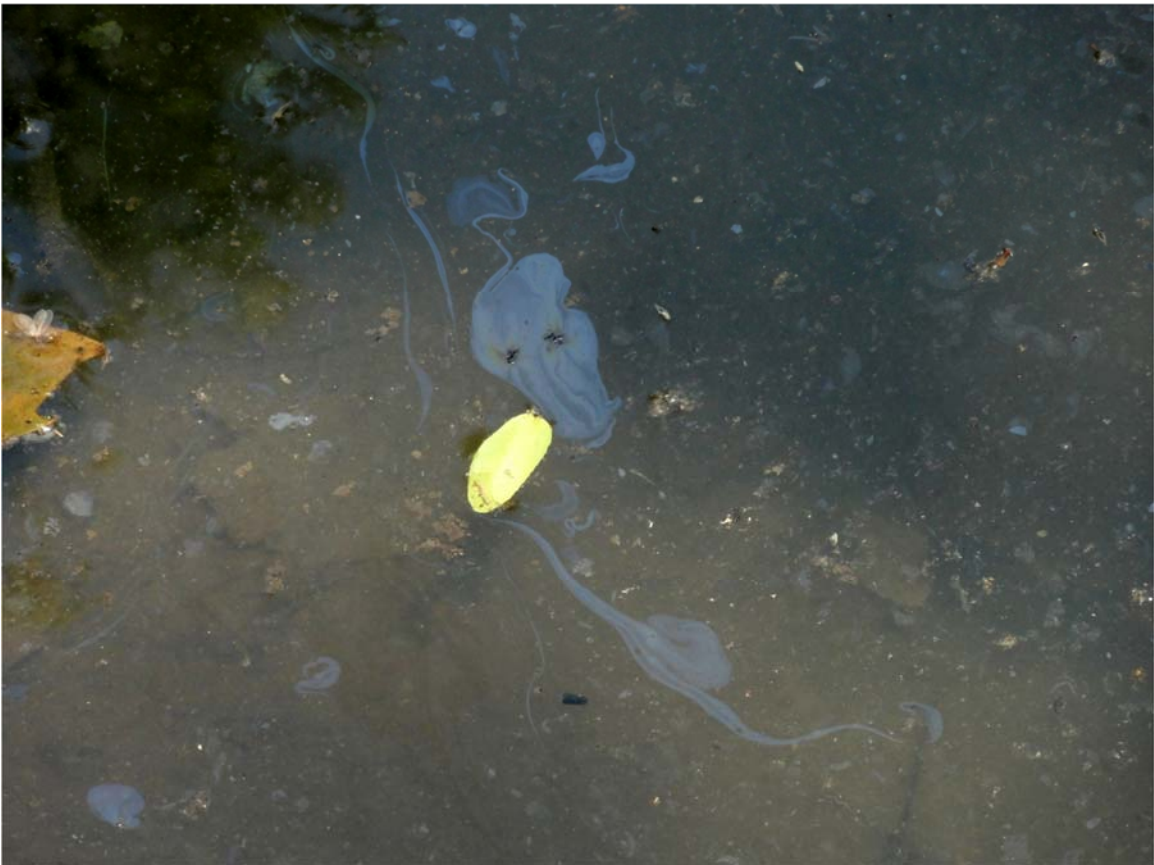
40. MP28.25 Oxbow sheen observed.

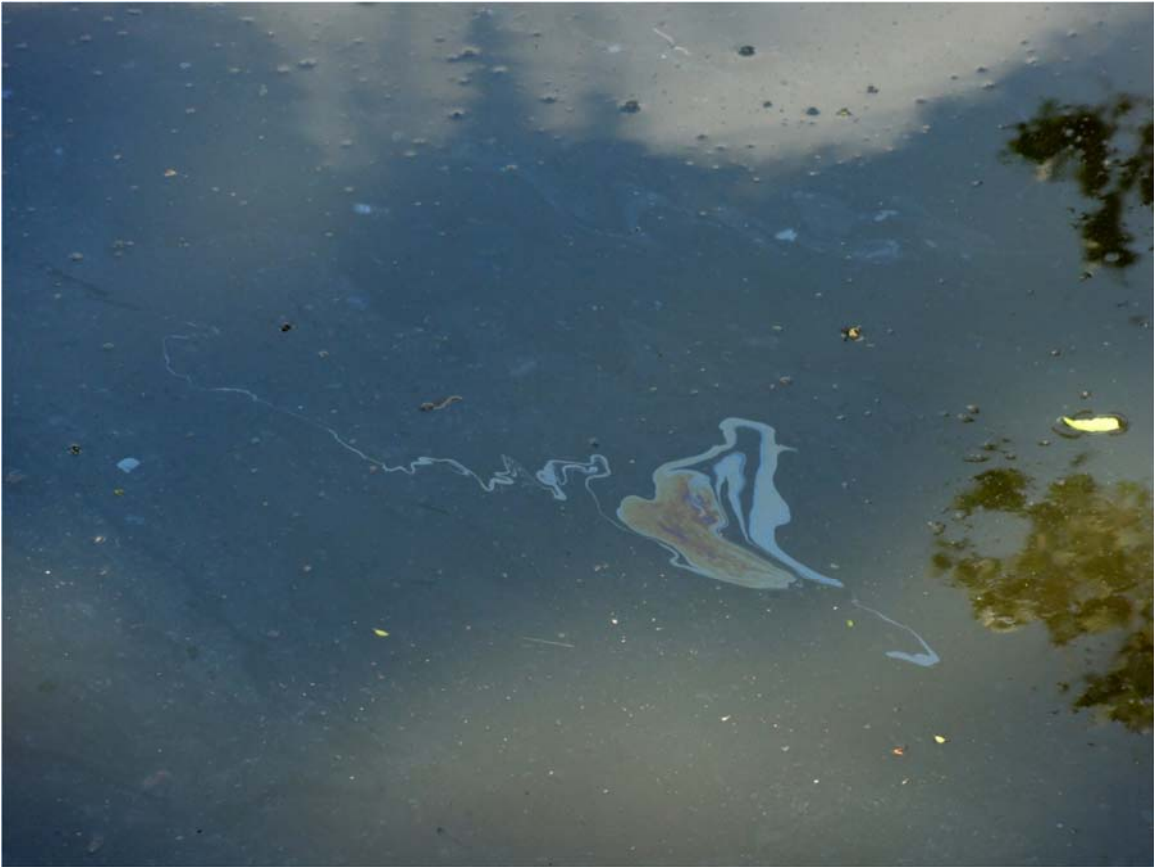
41. MP28.25 Oxbow sheen observed.

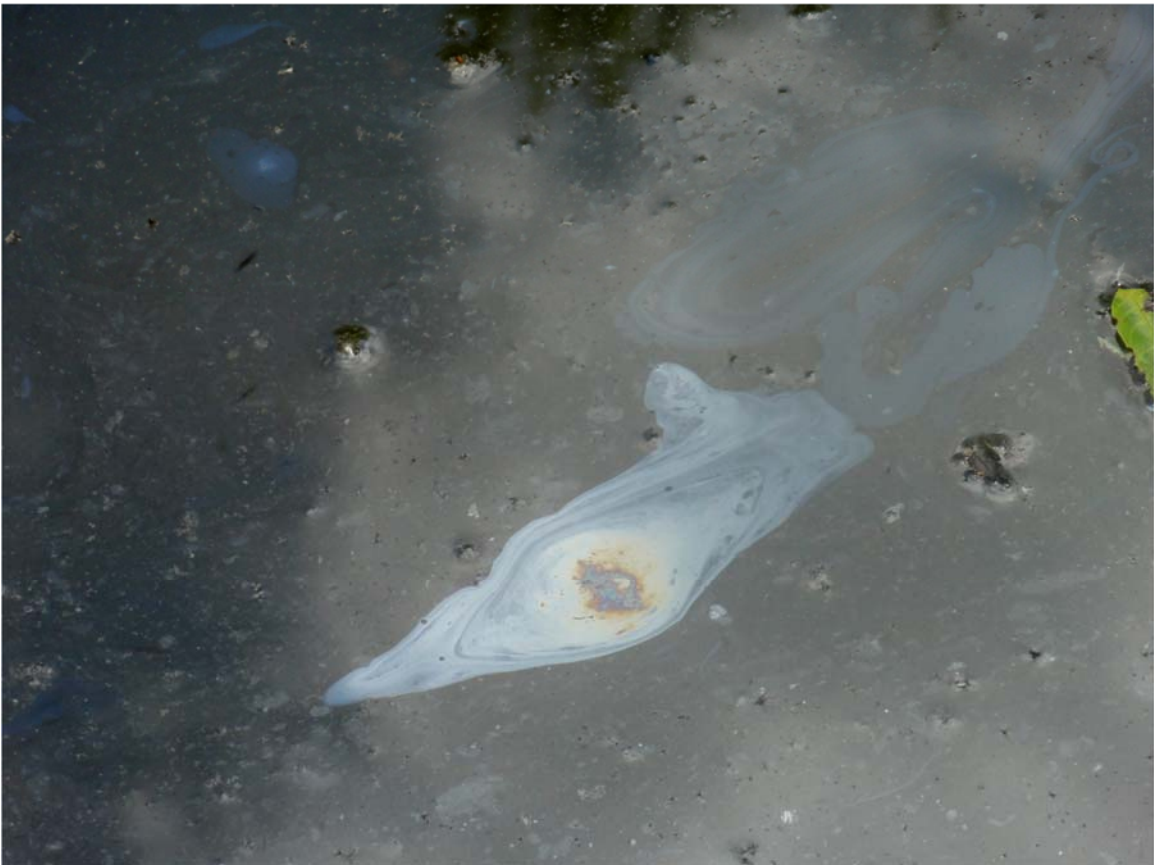
42. MP28.25 Oxbow sheen observed.

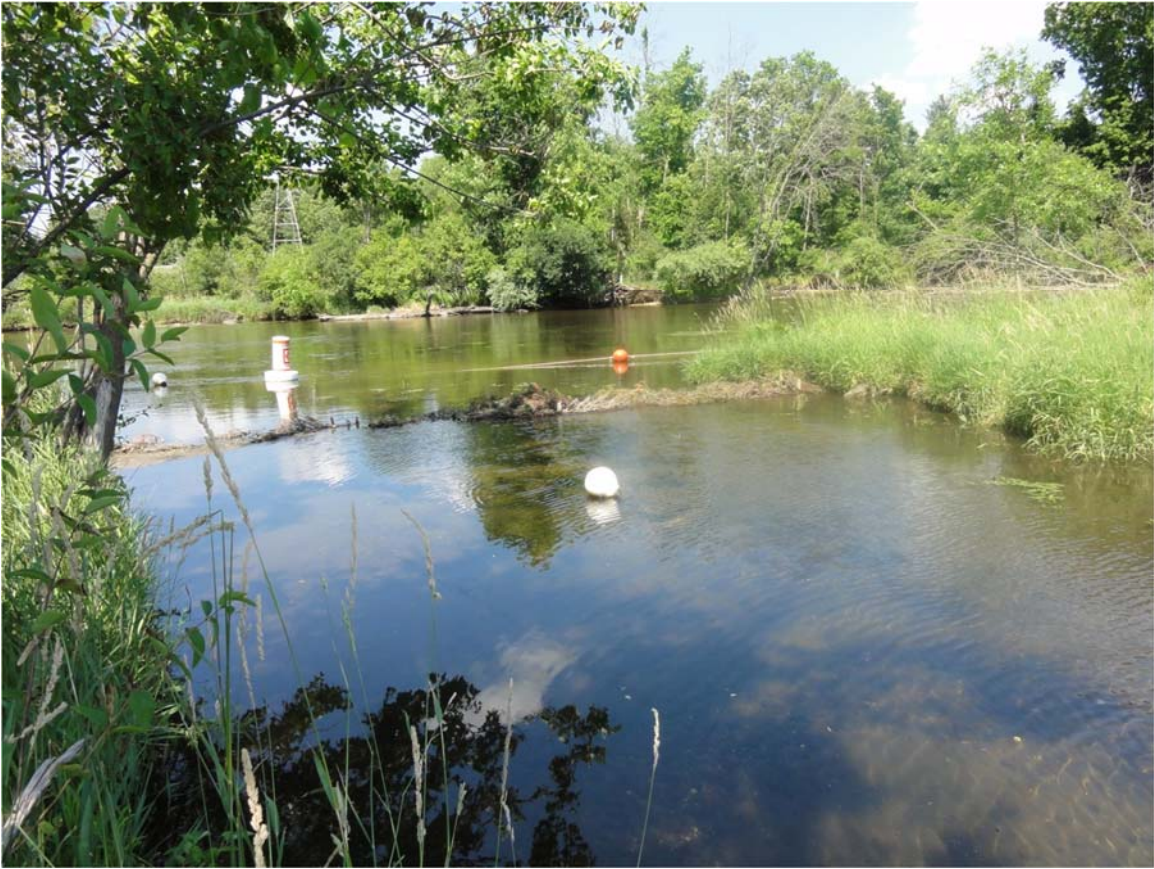
43. MP10.75 Sediment trap.

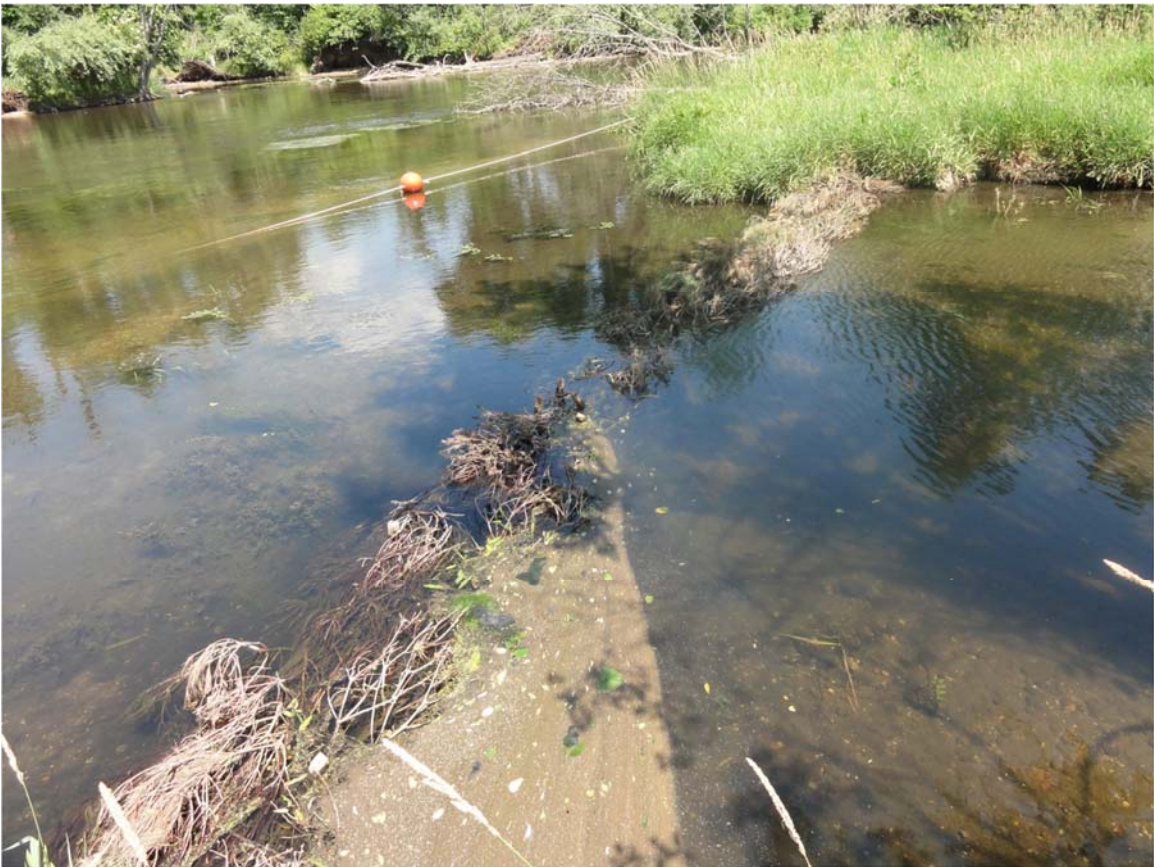
44. MP10.75 Sediment trap.

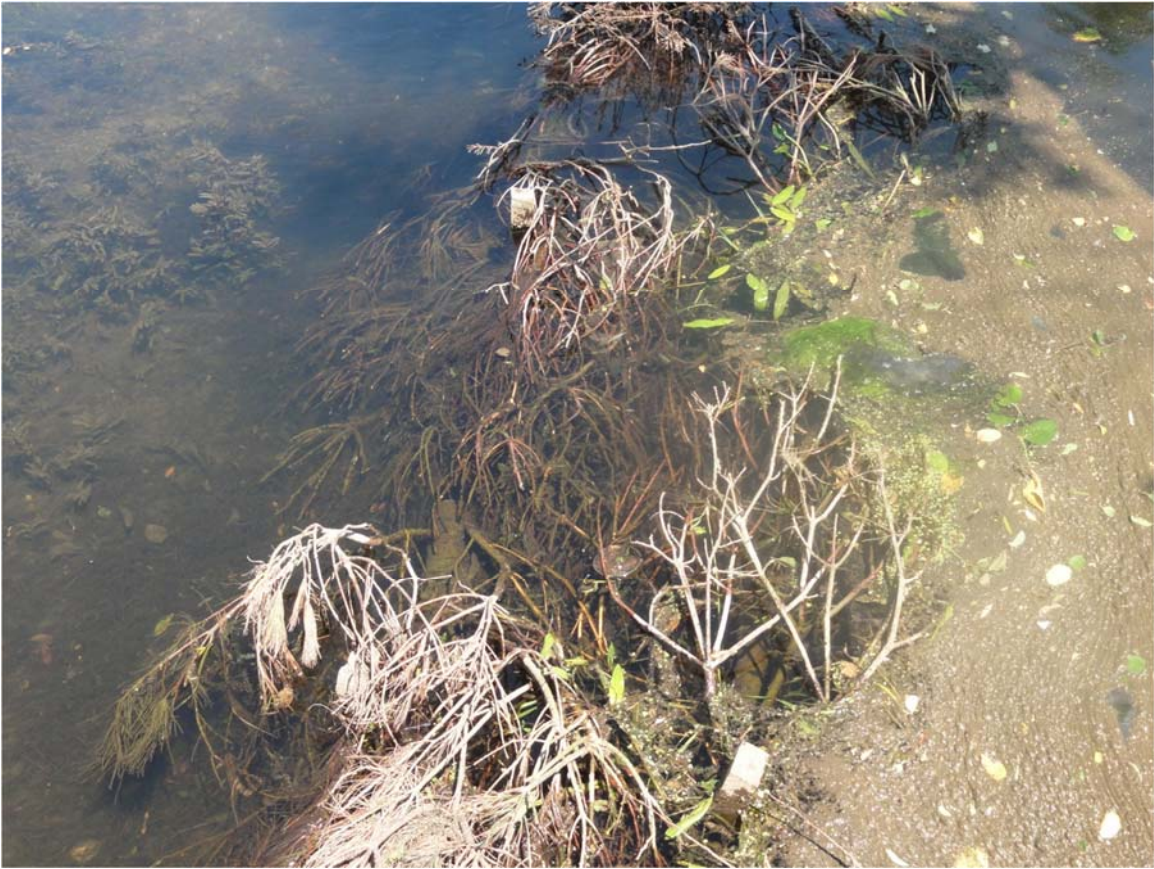
45. MP10.75 Sediment trap.

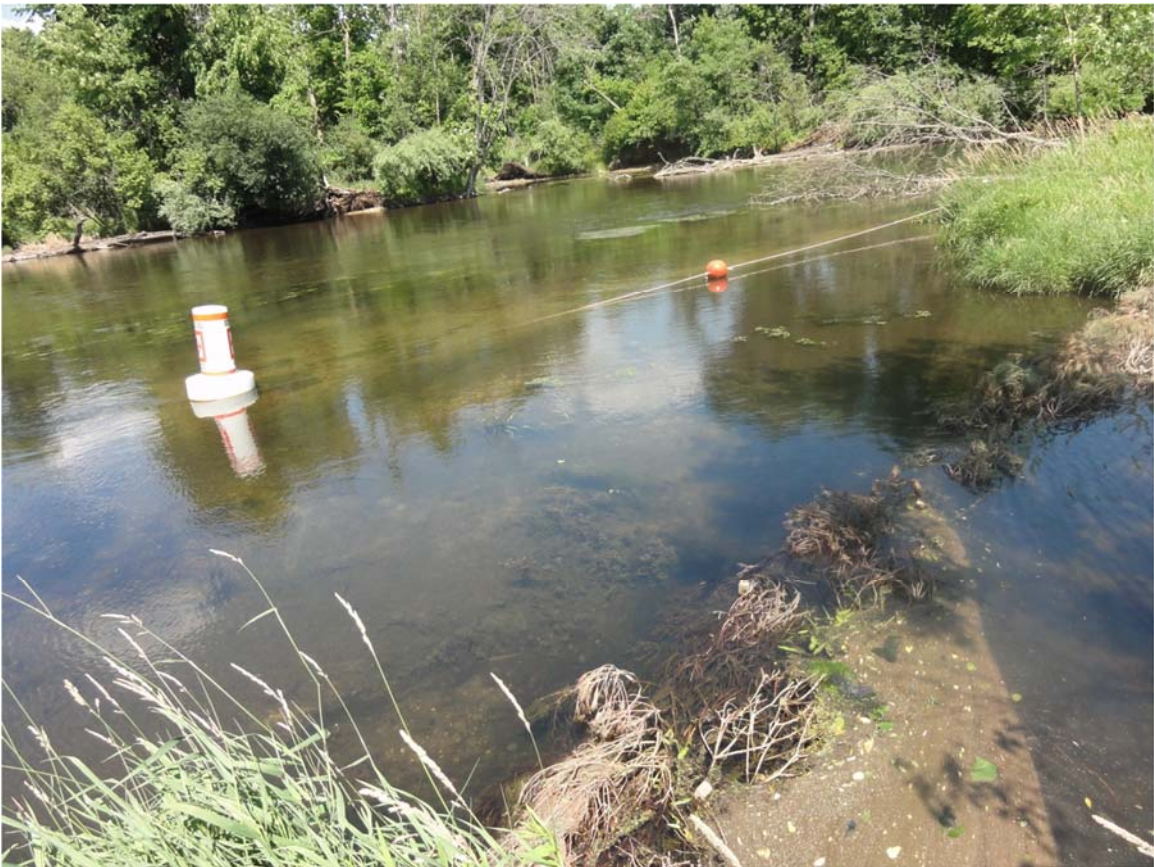
46. MP10.75 Boom removed.
